## Church of St Dunstan, Monks Risborough

### Quinquennial Inspection

May 2022

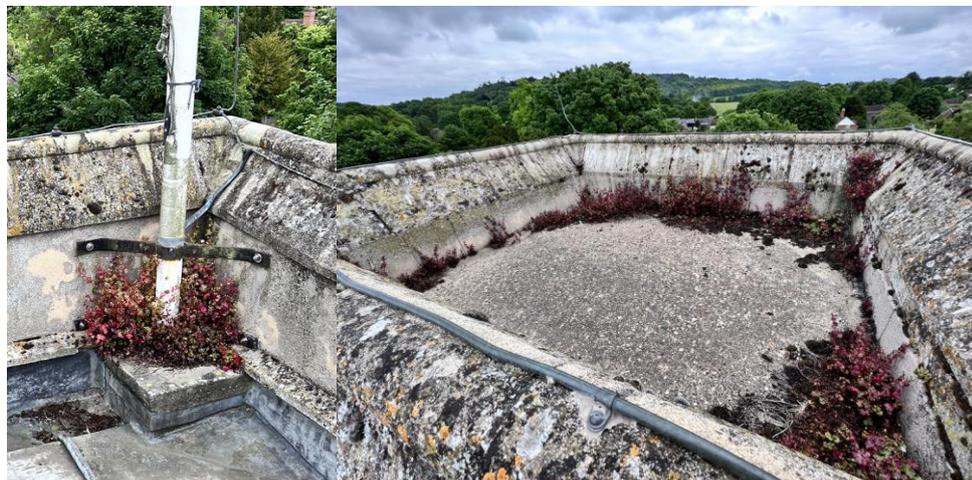
4.2.2\* There is some vegetation on the tower roof that should be removed. The flag pole has a plant growing around the base, and the asphalt roof to the stair turret also has some vegetation growing around the edges that also needs removing (figure 1). Stonework damage can be caused by root systems and increased moisture build-up, so it is important not to allow plants to grow in masonry. **2**

Figure 1 – Tower roof – vegetation growth – remove.

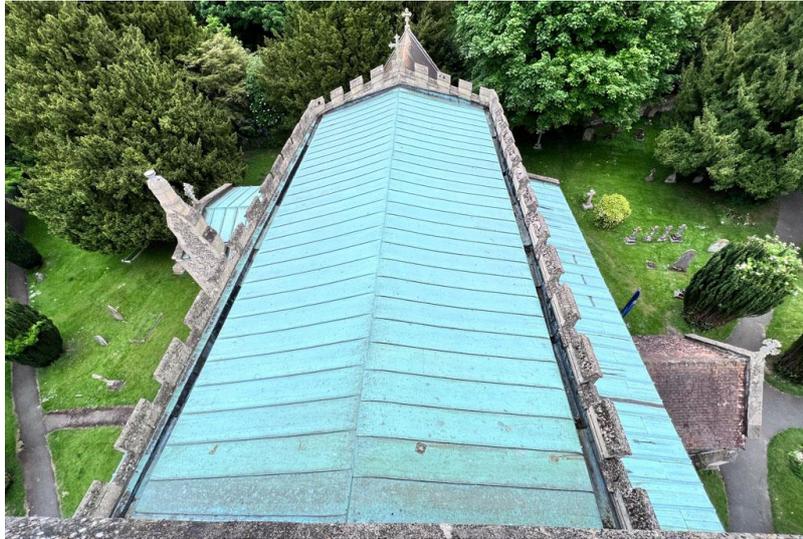
The copper roofs were viewed from the top of the tower and all appear to be in good condition (figure 2).

Figure 2 – Copper roofs in good condition.

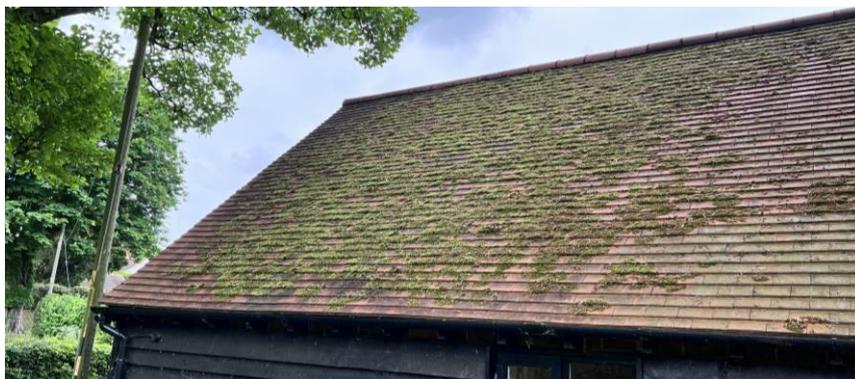
The clay tile roof of the church hall is in good condition. Moss build-up, especially on the east side where it is overshadowed by a nearby tree, should be casually monitored and reassessed at the next inspection (figure 3).

Figure 3 – Church hall – monitor moss build-up.

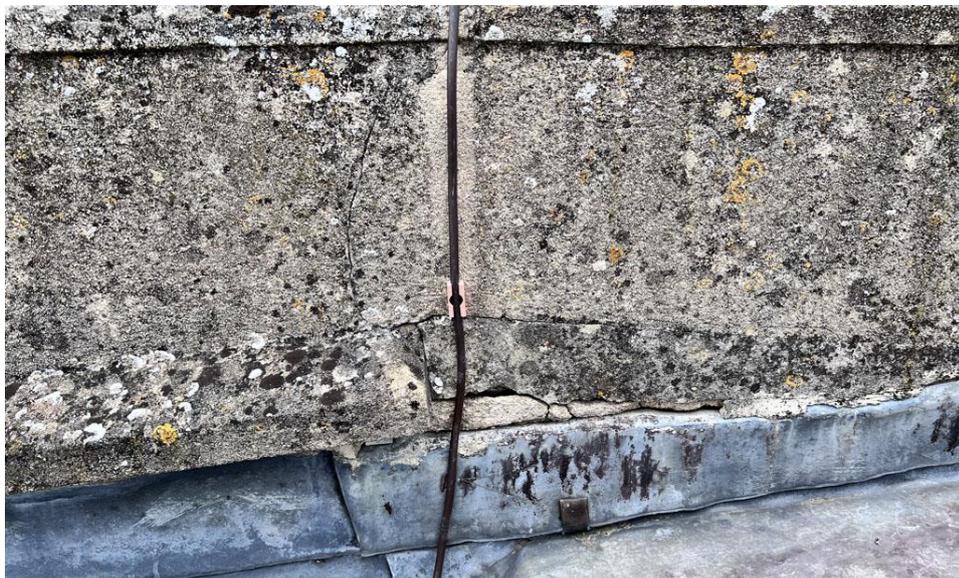
- 6.2.1\* The inner edge of the tower parapet requires some minor repointing where there are some open joints and cracking in the render (figure 4).

Figure 4 – Tower parapet – minor cracks in render – repoint in lime.

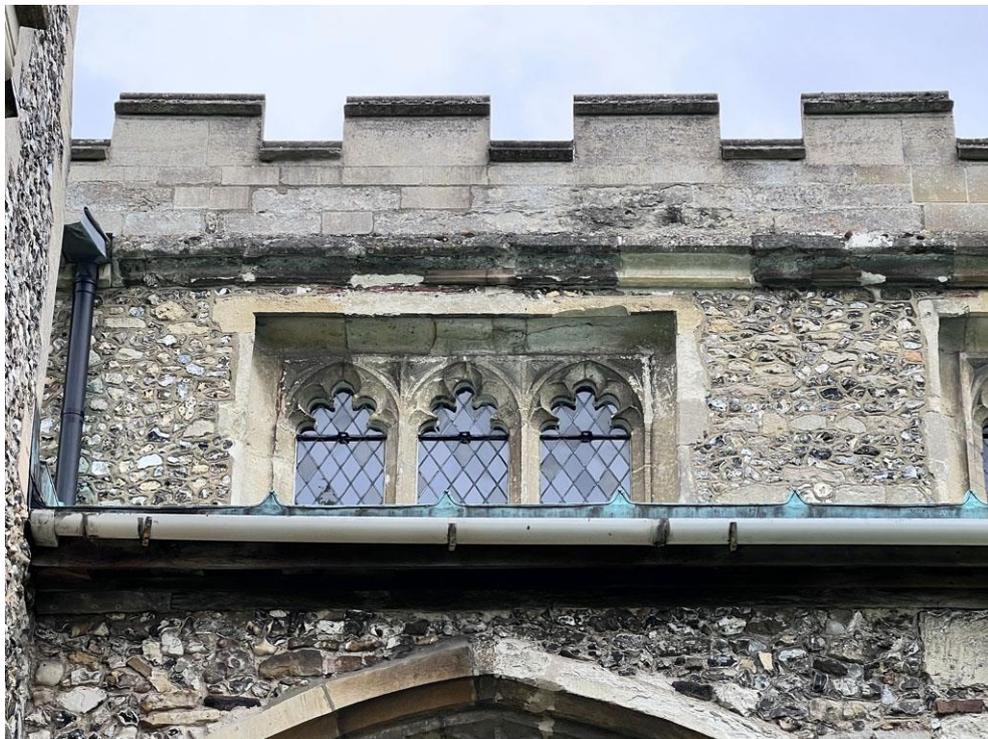
- 6.3.1 The external walls of the nave are flint and stone with dressed window reveals, quoins and crenellations above. The walls to the south and north are clerestory, with the east end wall gabled, with continued crenellations linking the south and north sides together. The walls were viewed from ground level.
- 6.3.2\* Overall, the external walls of the nave appear to be in good order with no major work required. There is some weathering to the string course below the crenellations, but this appears to be minor and there is nothing too concerning – reassess at the next inspection (figure 5).

Figure 5 - Nave, north side clerestory – weathering to the string course below the crenellations.

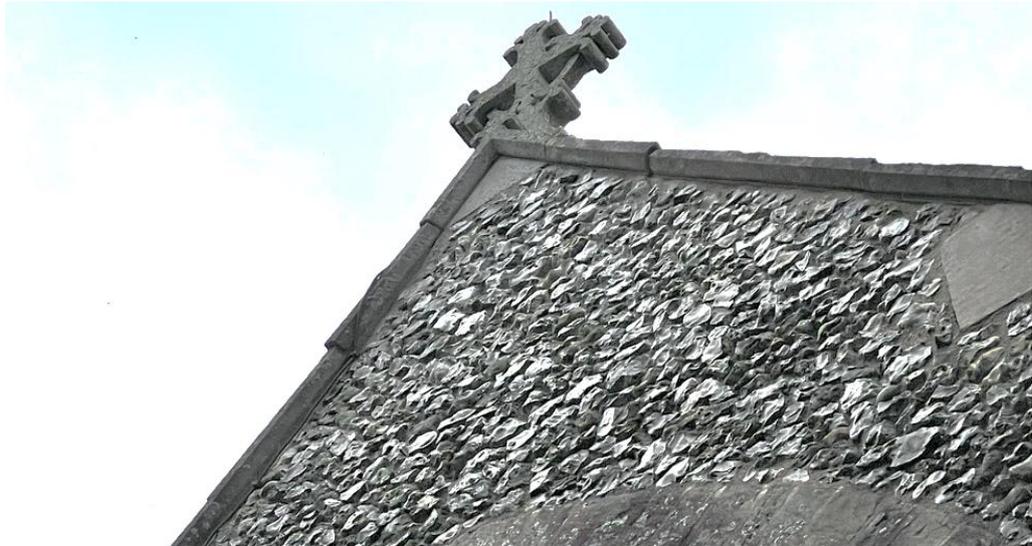
Generally, the walls of the chancel and vestry are in good condition. There is minor misalignment of the top apex copings, but no action required (figure 6).

Figure 6 - Chancel, east end apex copings – minor misalignment of the top copings.

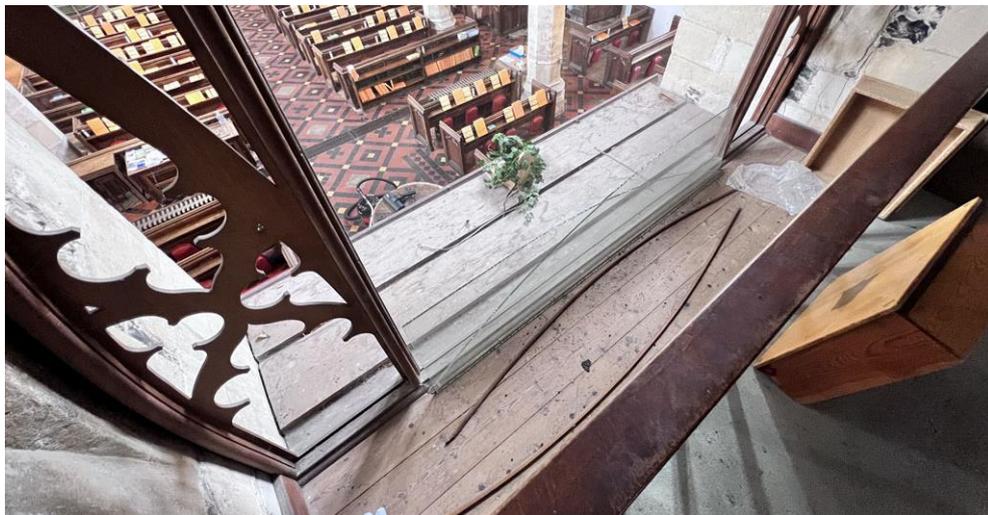
7.2.2 The bell ringing chamber has a glass infill panel between the tower and the nave. The two, curved, side panels have been removed (figure 7). The reason for their removal is unclear.

Figure 7 – Bell ringing chamber – glass panels removed.

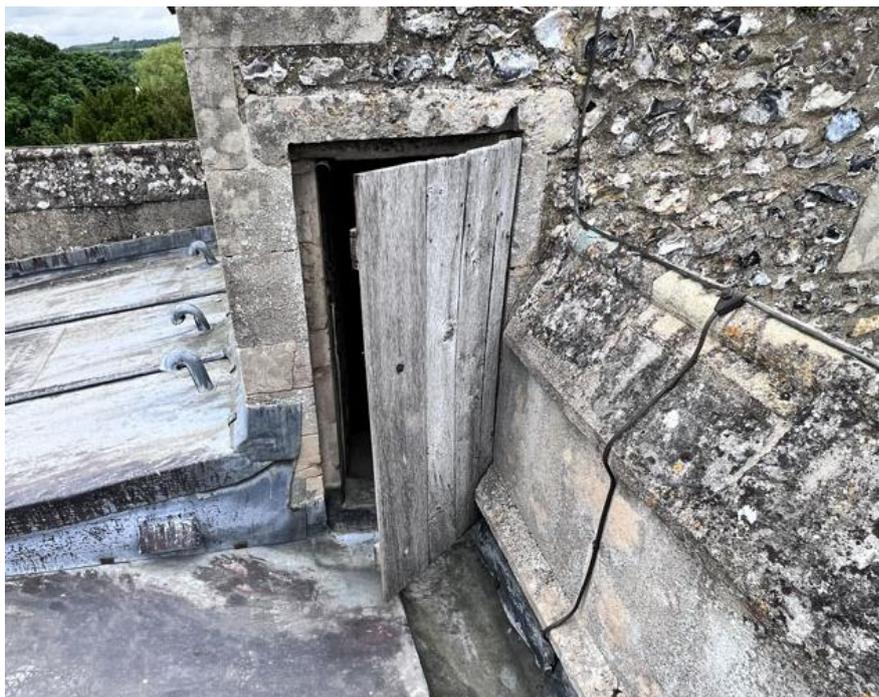
8.2.2\* The tower parapet door is looking a little dry and could do with treating with Danish oil (figure 8).

Figure 8 – Tower parapet door – treat with Danish oil.

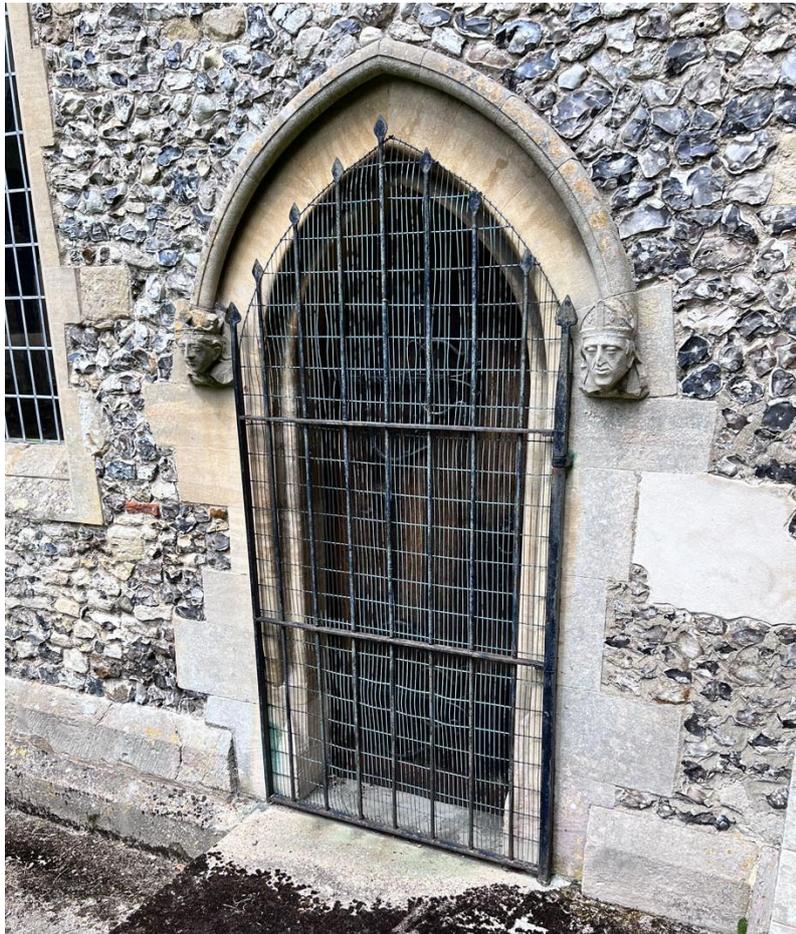
8.3.2\* The door in the south wall of the chancel is not used and has a fixed iron gate across the outside (figure 9). It is beginning to rust and could do with some redecoration. The mesh is showing signs of wear and is beginning to oxidise, causing some staining to the stonework at the bottom. It would be good to replace the mesh with stainless steel, painted black to prevent further discoloration of the stonework.

Figure 9 – Chancel, south – door protection showing wear – refurbish.

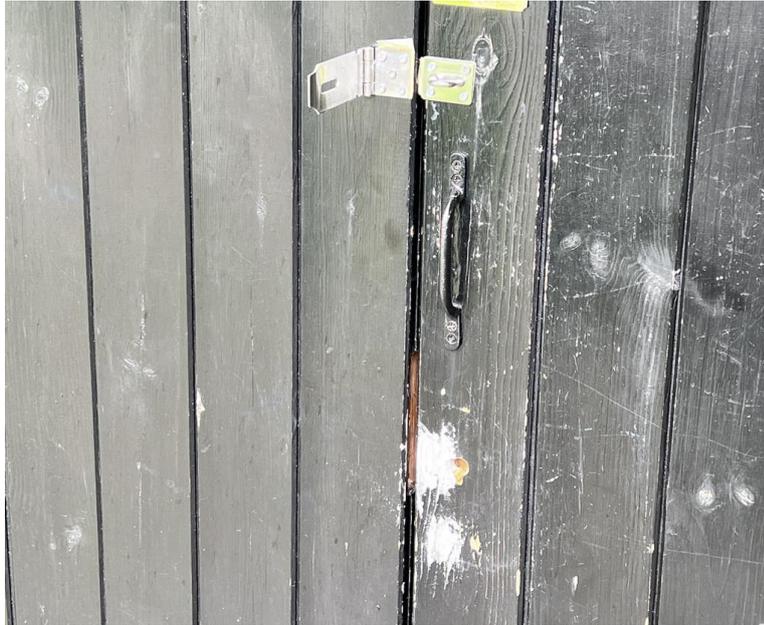
The main entrance door into the church hall has some cosmetic damage where the lock has been removed (figure 10). This should be repaired and redecorated.

Figure 10 – Church hall – cosmetic damage to door – repair.

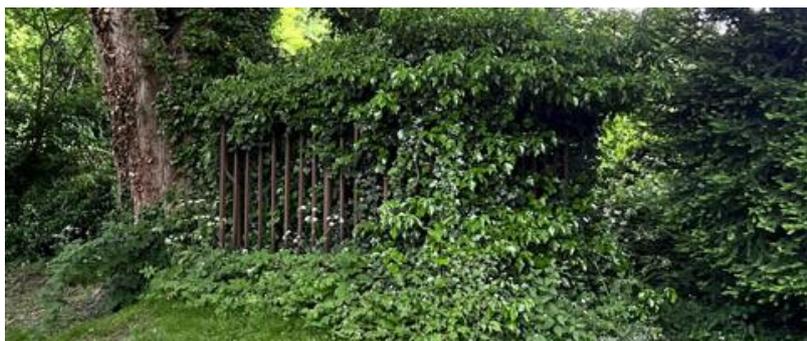
9.2.2\* There is what appears to be fenced tomb, close to the south boundary, that is very overgrown (figure 11). It would be good to clear this at some point and refurbish the metal fencing.

Figure 11 – Churchyard – possible overgrown tomb – clear.

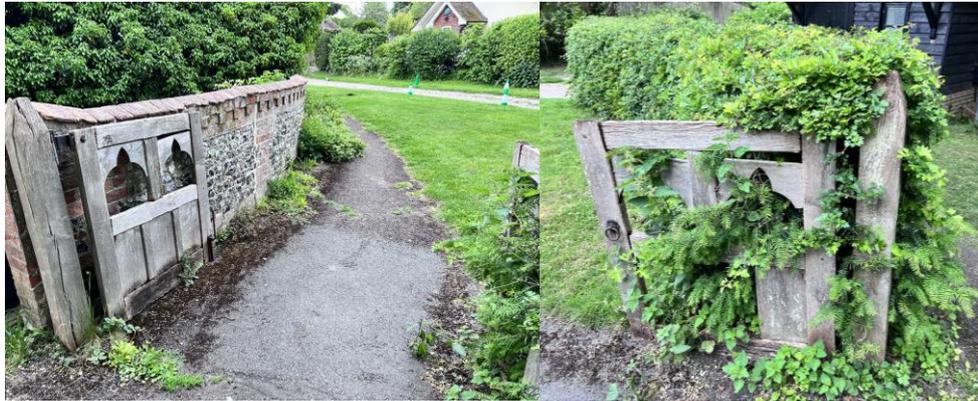
9.3.2\* The main south entrance gates to the churchyard require rebuilding (figure 12).

Figure 12 – Churchyard, south entrance gates – re-build.

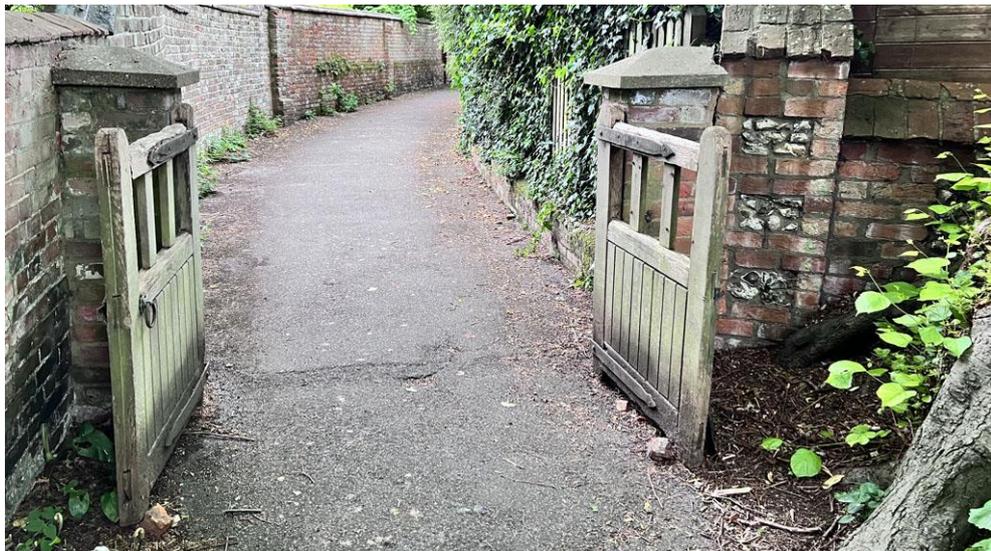
9.3.3\* The gates at the southeast corner of the churchyard are serviceable but may require some attention in the near future (figure 12). If work is being carried out to the main south entrance gates, it might be good to have these gates looked at, otherwise they should be monitored and reassessed at the next inspection.

Figure 12 – Churchyard, southeast corner – gates starting to show signs of deterioration – monitor and reassess.

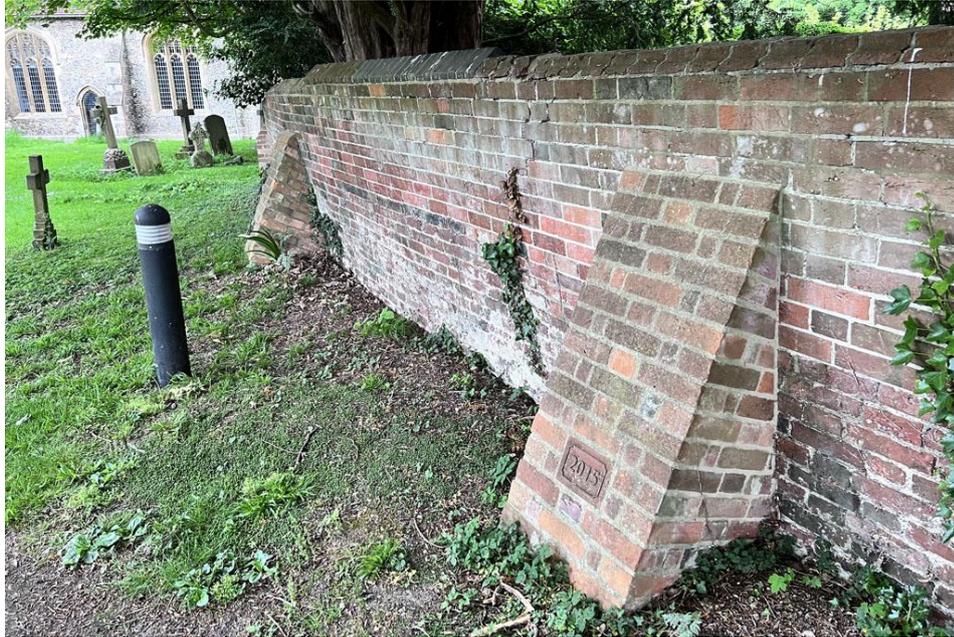
9.3.4\* The east boundary brick wall is leaning where it runs close to a tree, and some cracks are showing in the brickwork (figure 13). Buttresses have been built to

help stabilise the wall. The ivy growth should be cleared to prevent further deterioration of the brickwork.

Figure 13 – Churchyard, east boundary wall – remove ivy growth.

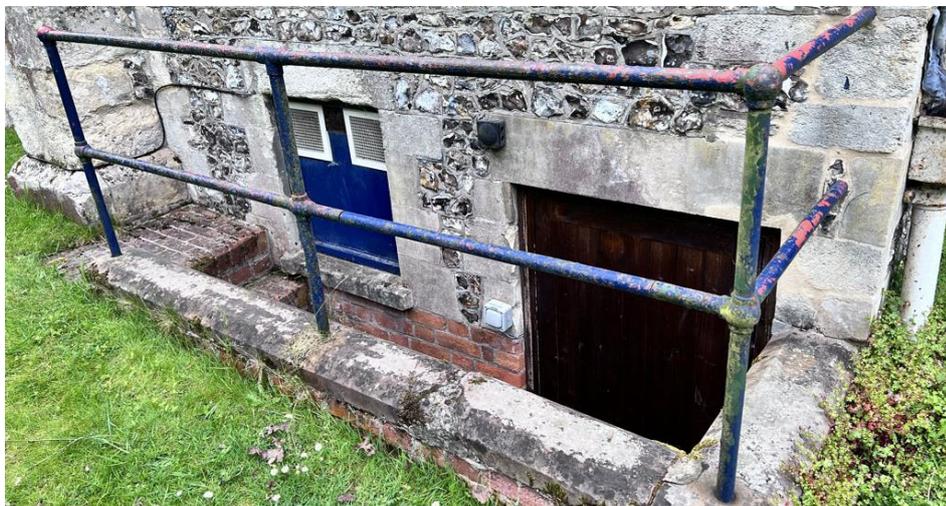
The metal railings around the boiler room entrance require redecorating (figure 14).

Figure 14 – Boiler room entrance – redecorate railings.

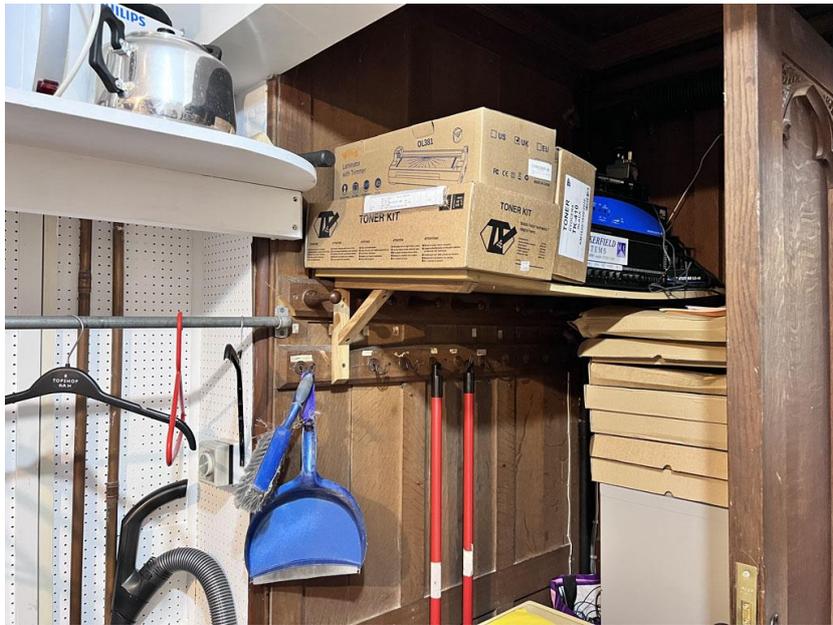
The lower tower area is generally in good condition, though slightly cluttered as it is a bit of a multi-use area, and access is required to the bell ringing chamber, tower stairwell, and west end door. Some of the shelving could be improved as it is bowing (figure 15). It could be worth thinking about re-ordering this area to make more efficient use of space.

Figure 15 – Lower tower – improve shelving.

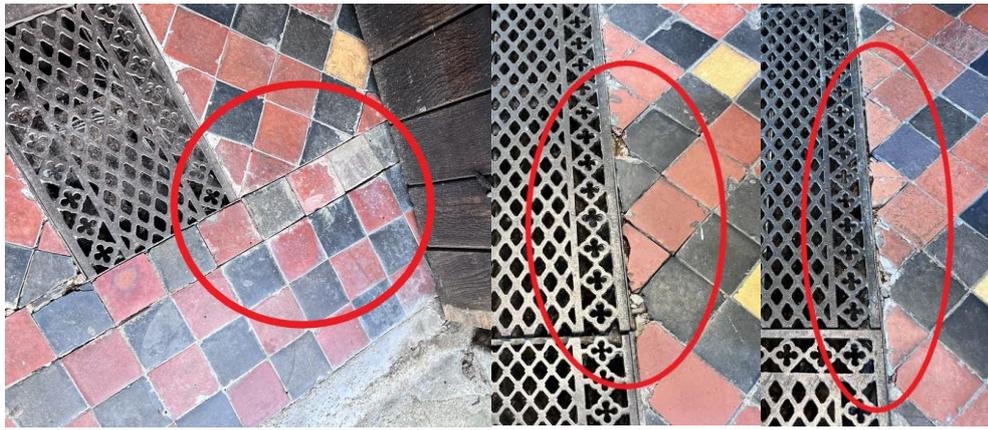
10.5.2\* There are a few loose tiles here and there that could do with re-setting (figure 16). There is one triangle edge tile loose in the northwest corner, and a few just inside the north aisle external door. There are also a few loose and broken towards the east end of the nave/north aisle along the edge of the metal grating.

Figure 16 – Nave/north aisle – loose and broken tiles – re-set.

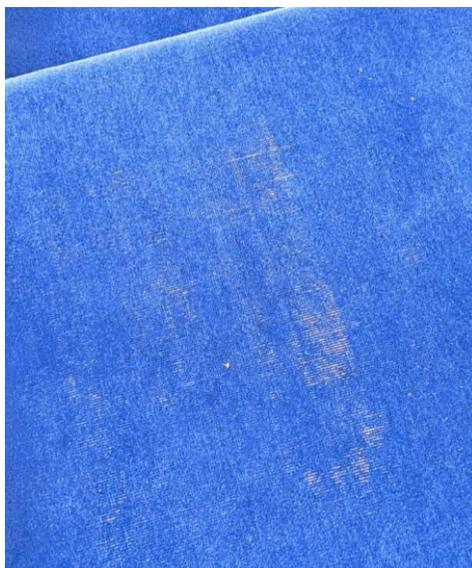
10.6.2\* The high end of the chancel is fully carpeted, and is generally in good condition. There is a patch of wear to the carpet on the south side (figure 17). This should be reassessed at the next inspection.

Figure 17 – Chancel – worn patch on carpet.

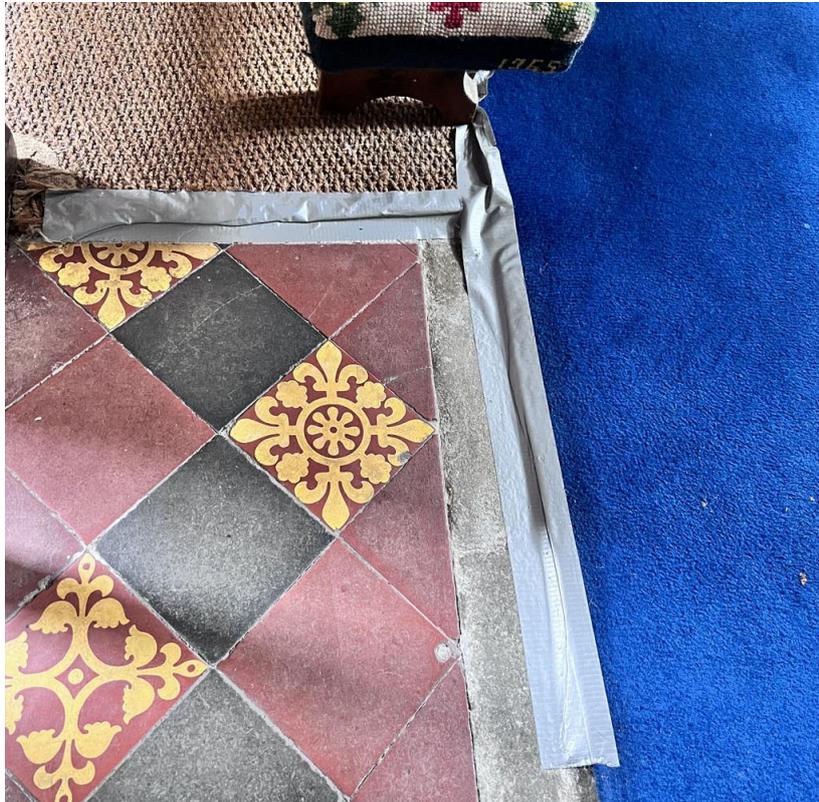
10.6.3\* The edges of the carpet have been stuck down with tape. It looks a little unsightly and a more aesthetically-pleasing solution should be sought long term (figure 18).

Figure 18 Chancel – carpet edge stuck down with tape – replace with something less unsightly.
