## Church of St Dunstan, Monks Risborough

### Quinquennial Inspection

May 2022

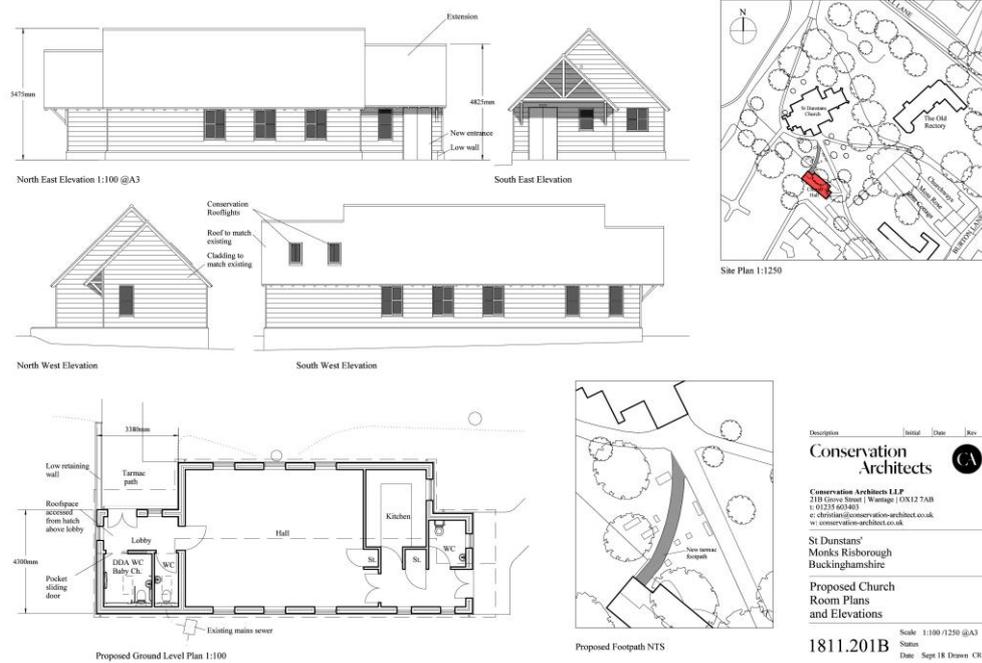
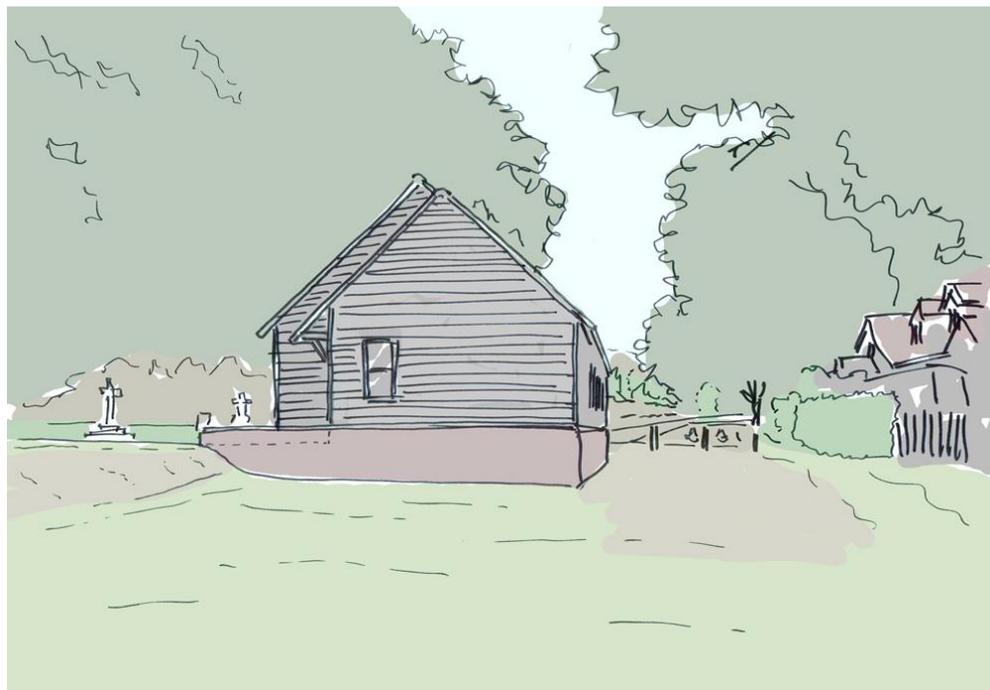
Figure 19 – Proposed plan and sketch of the extension of the church hall.

11.4.3\* The church obtained planning permission and faculty to extend the church hall to provide additional toilet facilities (figure 19). Planning permission will expire in September 2022. It may be worth considering ‘starting the development’ so that the permission stays in place indefinitely.
